NPS
INVENTORYNational Park Service
Pacific Northwest Region
Cultural Resources DivisionWestin Building, F 1920
2001 Sixth Ave
Seattle, Washington 98121

White River Campground Patrol Cabin

White River Campground W-051

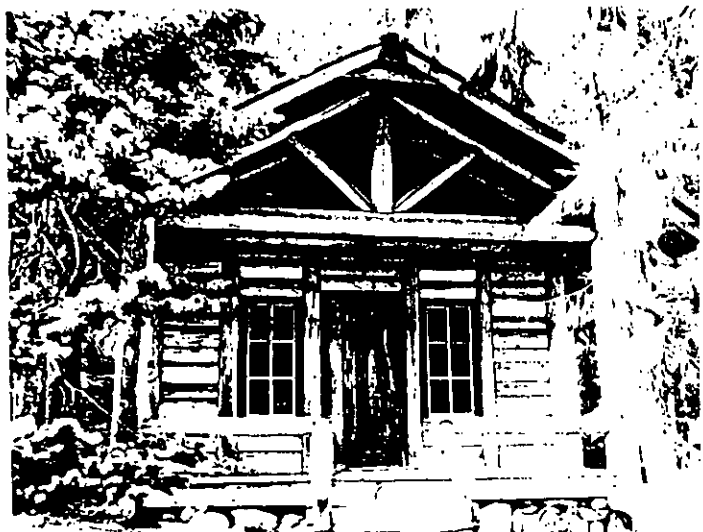
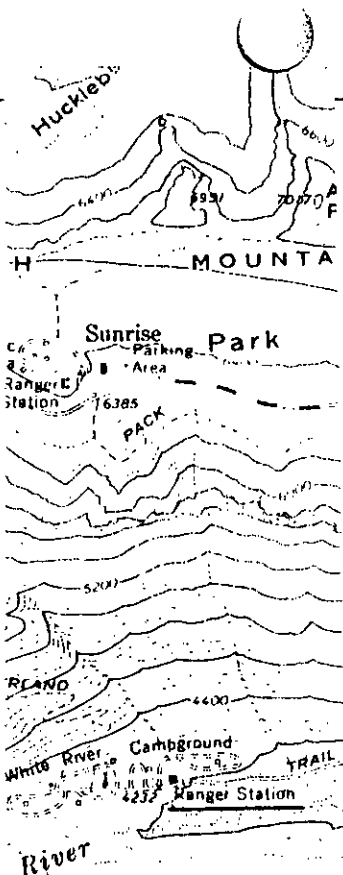
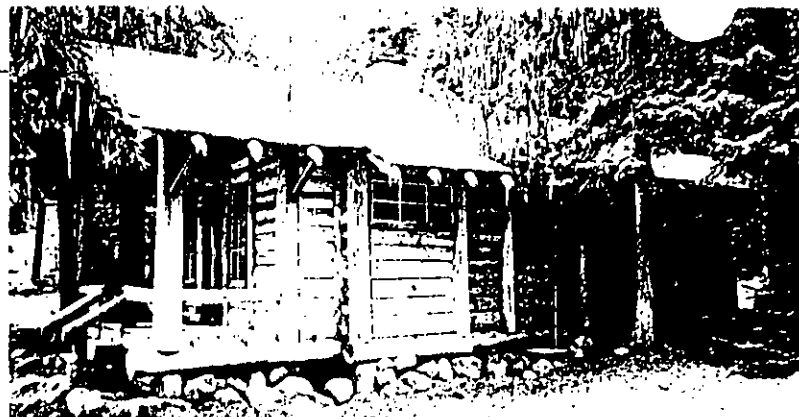
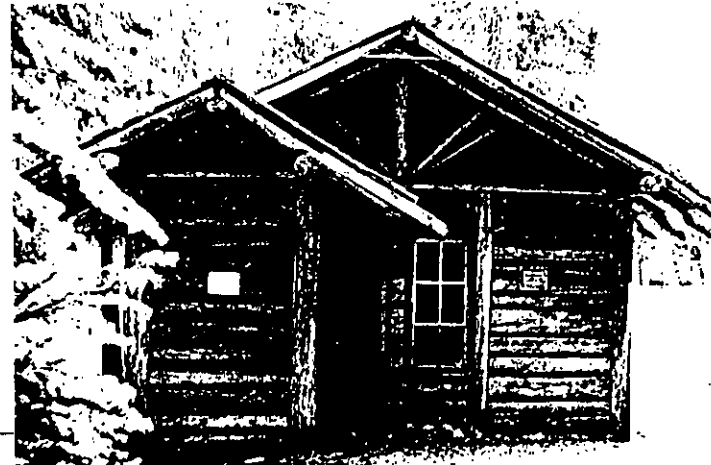
17. PHOTOS AND SKETCH MAP OF LOCATION

Wood and log post and beam frame, one story, three room, rectangular cabin; medium pitched gable roof extends over log post and beam porch that spans the entire width of the front facade, and over a recessed side porch; front and rear facade log trusses; log ridge beam; projecting eaves and verges; log rafters with whittled ends project beyond roof line; stone veneer brick chimney off gable ridge; split-log horizontal veneer siding nailed to studs; shower room addition has vertical board and batten siding; pivot-casement windows; unfinished interior fibreboard (celotex) walls; exposed ceiling beams; plywood floors; stone infill, log beam, and pier foundation.

With the construction of the White River Campground in 1923, there became a need for a ranger station at the site. Built in 1927 by the National Park Service, the White River Campground Ranger Station was regarded as a patrol cabin because it was on the Wonderland Trail (Thompson 1981). The cabin was remodeled in 1949: the interior walls were finished with celotex, and plywood was placed over the shiplap floor (Carper 1976). The structure measures 16.5' x 30.5', with a floor size of 495 square feet. The open front porch is 5' x 16.5', the recessed side porch is 5' x 6'4". The cabin is in poor condition: abandoned, filled with trash, and rodent infested. The exposed ends of the rafters are deteriorating and the roof is sagging.

☐ EXCELLENT☐ GOOD☐ FAIR☒ DETERIORATED☐ RUINS15. DANGER OF DEMOLITION?
(SPECIFY THREAT)☐ YES☐ NO☒ UNKNOWN
